Routine Inspection Summary

Property Address: 24 Test Street, Te Aro, Wellington

Inspection for: 24 Test Street, Te Aro, Wellington
Date of Inspection: 01/10/2008 **Carried Out By:** Staff Member

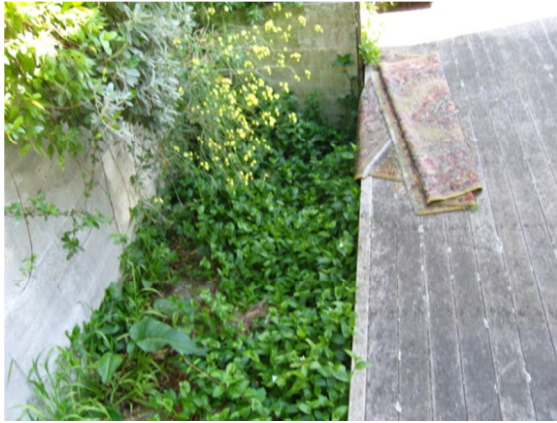
1:

Clear weeds from garden and clean deck.

| ◇ Garden needs weeding | |
| ◇ Deck needs cleaning | Good |

Notes. *Large weeds growing; see photos.*

A letter to remedy has been sent to the tenants and a follow up inspection booked.

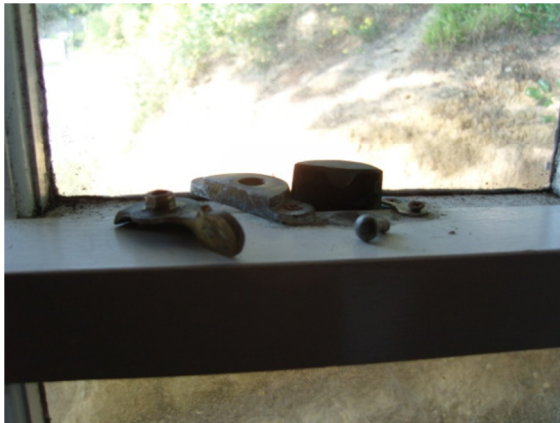
A window latch has broken – looks to be due to age.

Notes. *Window latch broken*

- 1: Have the path weed sprayed.
- 2: Have a contractor repair or replace the window catch.
